# EVALUATION OF THIN KEVLAR-EPOXY FABRIC PANELS SUBJECTED TO SHEAR LOADING

Donald J. Baker \*  
Vehicle Structures Directorate - ARL  
NASA Langley Research Center  
Hampton, VA 23681

The results of an analytical and experimental investigation of 4-ply Kevlar-49-epoxy panels loaded by in-plane shear are presented. Approximately one-half of the panels are thin-core sandwich panels and the other panels are solid-laminate panels. Selected panels were impacted with an aluminum sphere at a velocity of either 150 or 220 ft/sec. The strength of panels impacted at 150 ft/sec was not reduced when compared to the strength of the undamaged panels, but the strength of panels impacted at 220 ft/sec was reduced by 27 to 40 percent. Results are presented for panels that were cyclically loaded from a load less than the buckling load to a load in the postbuckling load range. The thin-core sandwich panels had a lower fatigue life than the solid panels. The residual strength of the solid and sandwich panels cycled more than one million cycles exceeded the baseline undamaged panel strengths. The effect of hysteresis in the response of the sandwich panels is not significant. Results of a nonlinear fi

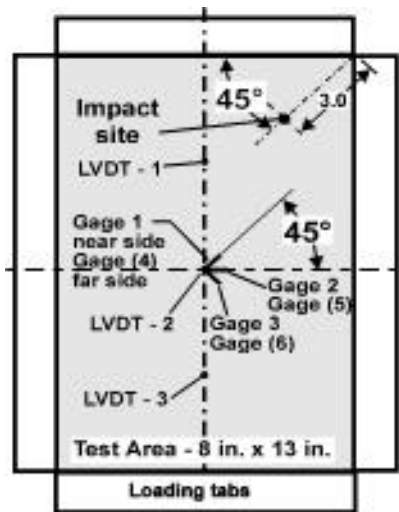
Figure 1. - Location of strain gages, impact site, and displacement transducers (LVDT).

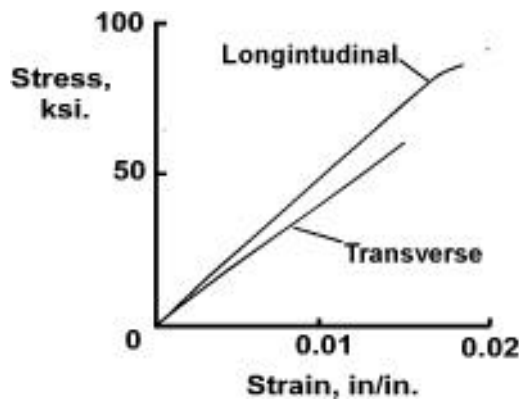
Figure 2. - Stress-strain curves for Kevlar-49-epoxy material used for the panels.

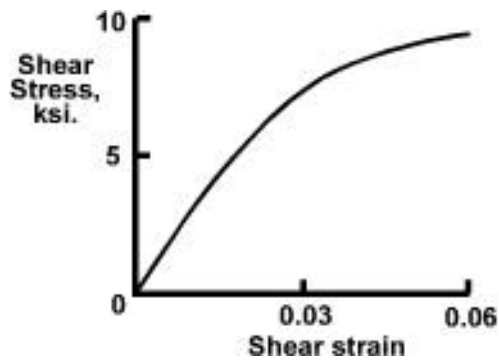
Figure 3. - Shear-stress-shear-strain curve for Kevlar-49-epoxy material used for the panels.

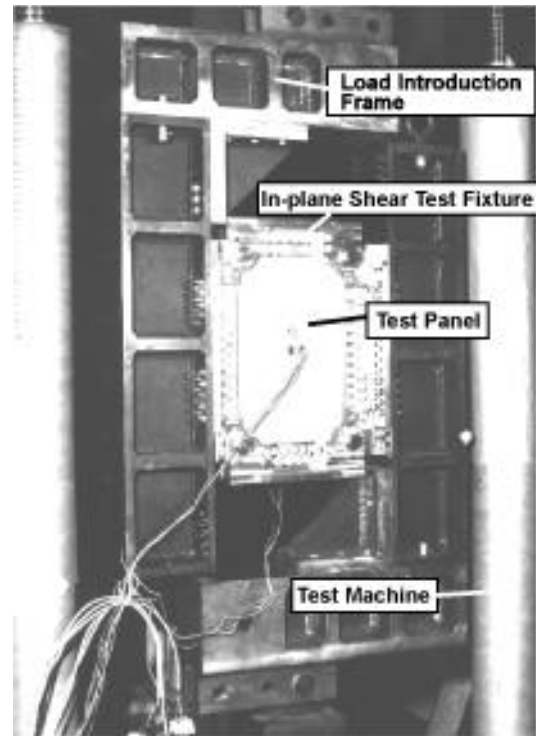
Figure 4. - Test setup with panel.

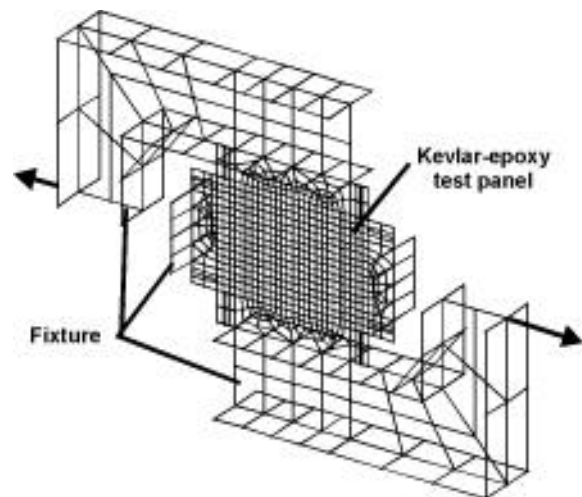
Figure 5. - STAGS finite element model of Kevlar-epoxy panel and loading frame.

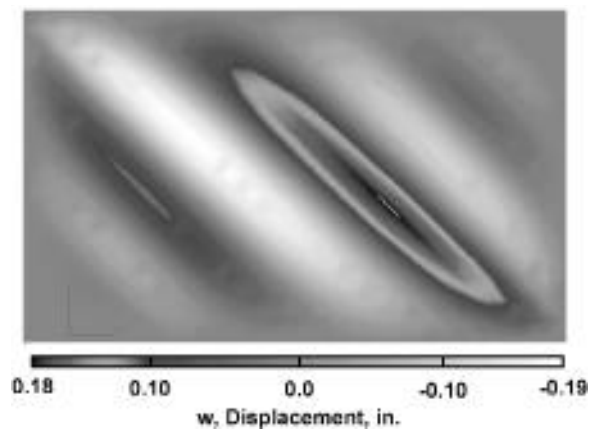
Figure 6. - Out-of-plane displacement predictions for  $N_{xy} = 850$  lbs/in.

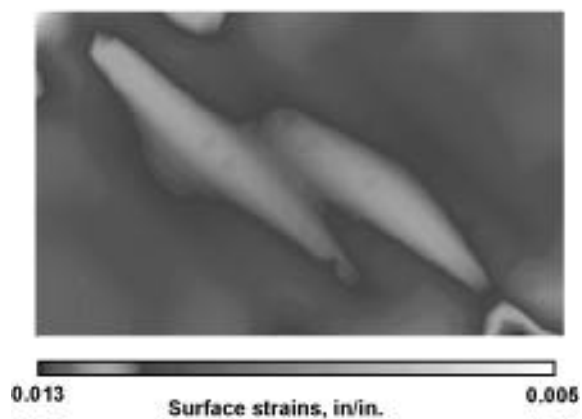
Figure 7. - Surface strain predictions, parallel to the buckle pattern for  $N_{xy} = 850$  lbs/in.

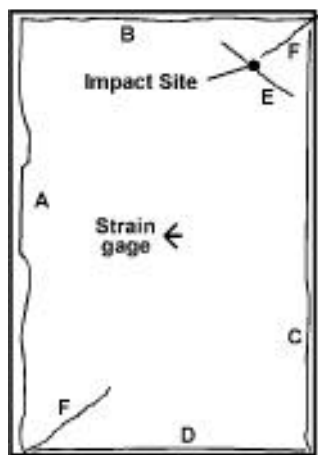
Figure 8. - Location of failure sites.

Generally, the solid panels failed by tearing along the load introduction tabs as shown in figure 8. The failure modes for each solid panel are summarized in Table 2 as a combination of letters shown in figure 8. Photographs of two failure modes are shown in figures 21 and 22. Laminate failure occurred in the laminate shown in figure 21, which is typical of a diagonal tension failure. Failure of a damaged panel is shown in figure 22 and extends along two sides and through the impact damage site.

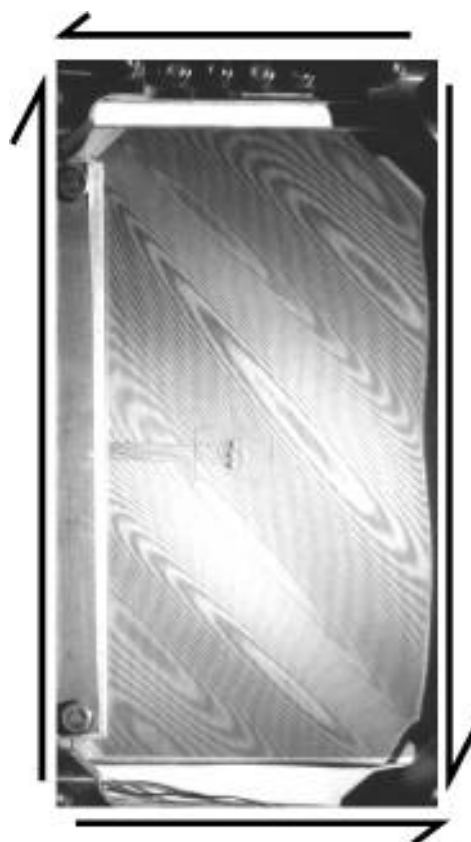
Figure 11. - Out-of-plane deflections as determined from moire pattern for  $N_{xy} = 851$  lbs/in.

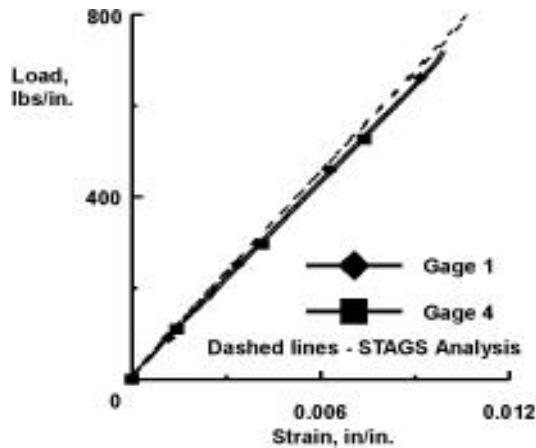
Figure 12. - Comparison of experimental and predicted strain, parallel to the buckle pattern.

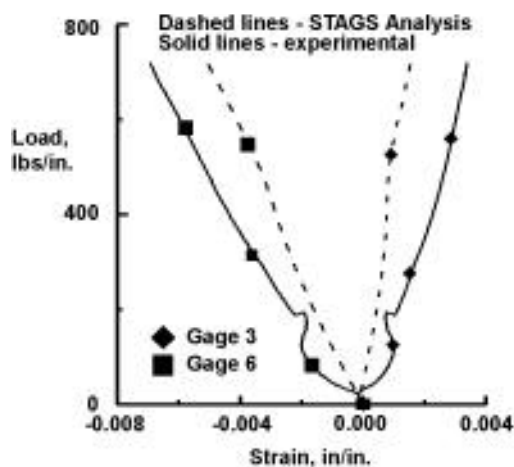
Figure 13. - Comparison of experimental and predicted strain normal to the buckle pattern.

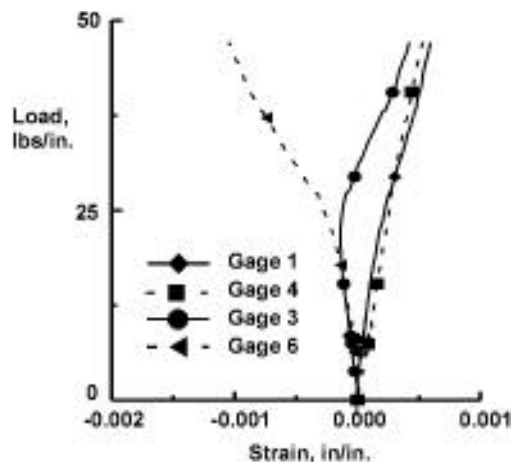
Figure 14. - Detail of experimental strain to a load of 45 lbs/in.

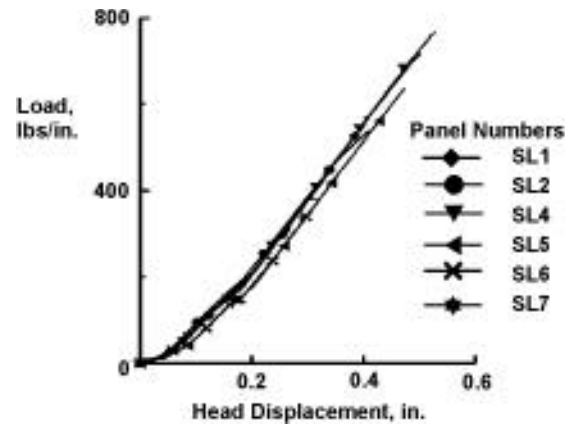
Figure 15. - Comparison of head displacements for solid panels.

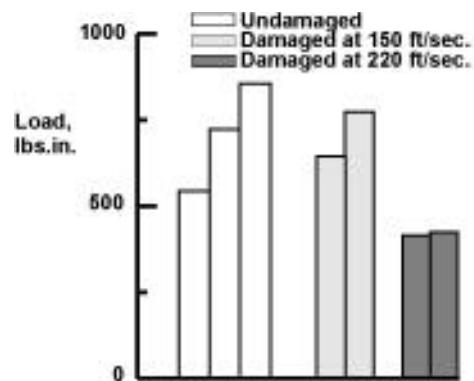
Figure 16. - Summary of failure strengths for solid panels.

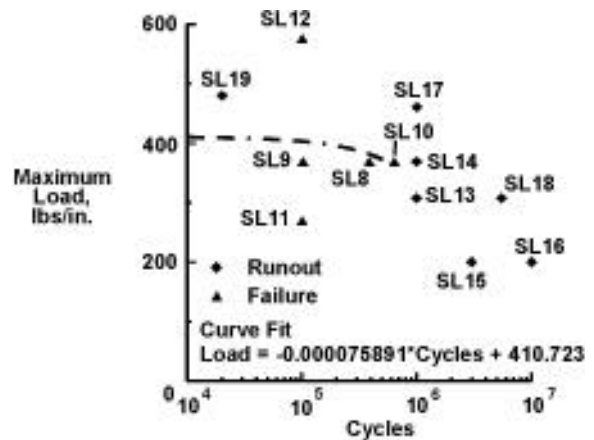
Figure 17. - Load as a function of load cycles for solid laminates.

A summary of the results for the solid panels that were cyclically loaded is shown in Table 2 and the maximum load as a function of load cycles is shown in figure 17. The diamond symbols are considered runout values and the panels were tested for residual strength. The residual strength results are shown in Table 2. A linear curve fit to the data from the five failed panels is

shown as a dashed line in figure 17. The coefficients for the curve fit equation are also shown in figure 17. More test results are needed in the low-load high-cycle region of the plot to complete the fatigue life curve. The average residual strength of the five undamaged solid panels that did not fail after one to three million load cycles is 763 lbs/in. This average residual strength is 107 percent of the baseline strength for the undamaged solid panels. Experimental and analytical out-of-plane deflections at the panel center and quarter point locations for a solid panel (SL12) are shown in figure 18. The calculated out-of-plane deflections have the same general trends as the experimental data but do not have the same magnitudes. This set of experimental curves indicates that a change has occurred in the panel response as indicated by the sudden change in the load-displacement curve when the load is approximately 180 lbs/in. The change in the curve could be caused by a change in mode shape or by a local failure. The out-of-plane deflections are repeatable for the different panels that have not been cyclically loaded. The out-of-plane deflections change in a panel as the number of cycles increases as can be seen in figure 19. The change in center deflection as the number cycles increase to 500,000 cycles is indicated in figure 19. This change in center deflection is typical for all solid panels. It appears as though the material stiffness decreased with increasing number of cycles thus changing the out-of-plane deflection shape. This decrease in material stiffness did not have a significant effect on the overall panel stiffness as shown in figure 20. The test-machine head displacement is shown in figure 20 as a function of load for a different number of load cycles applied to panel SL16, which was loaded with 10 million load cycles. All panels started to crack on the crest of the buckle at the panel corners soon after the testing was initiated, and the rate of crack growth varied for the panels. For the damaged panels, the crack propagated to the damage site and stopped for a period of time before continuing to propagate past the damage site. Crazing of the matrix occurred at various locations adjacent to the steel load introduction tabs.

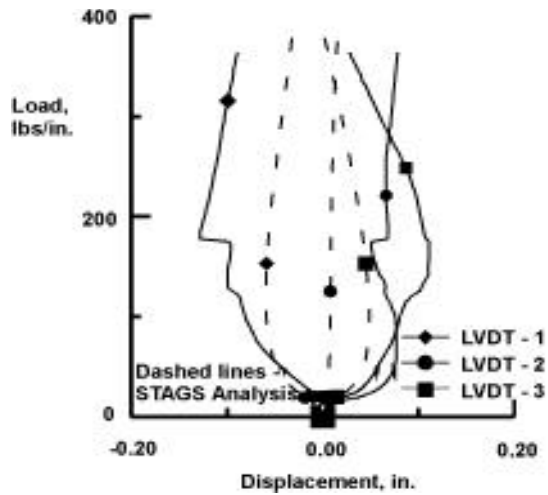
Figure 18. - Comparison of out-of-plane displacements with analysis on solid panels.

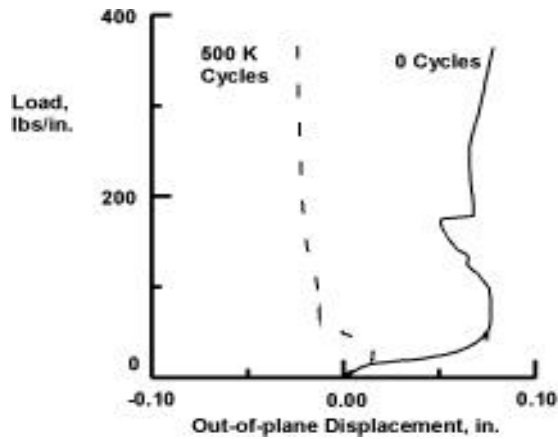
Figure 19. - Comparison of center out-of-plane displacements for different cycle accumulation on a solid panel.

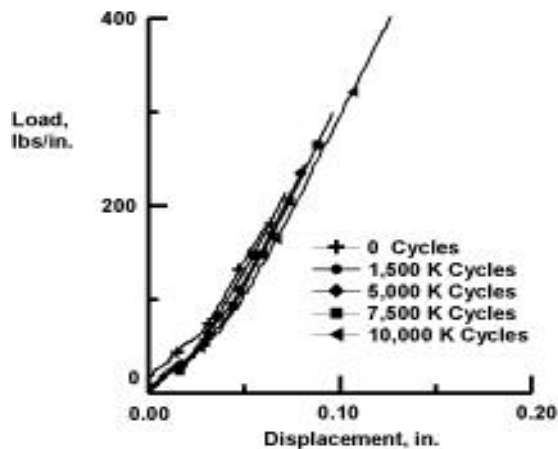
Figure 20. - Comparison of head displacements for different number of cycles on panel SL16.

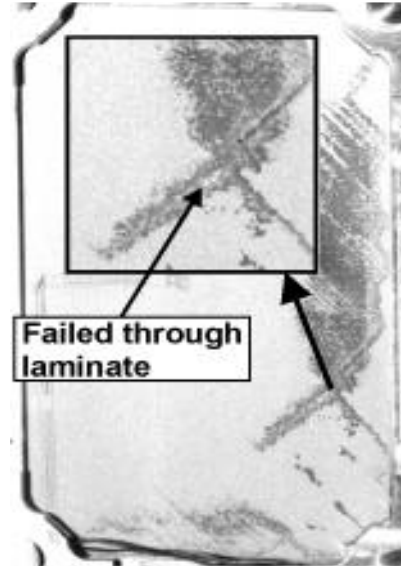
Figure 21. - Photograph of failed panel SL3.

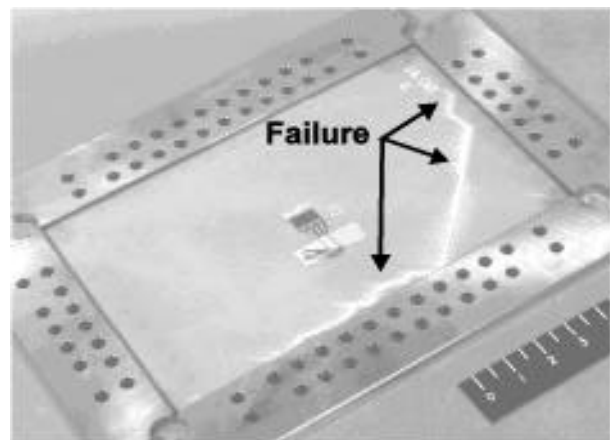
Figure 22. - Failure of damaged panel SL5.

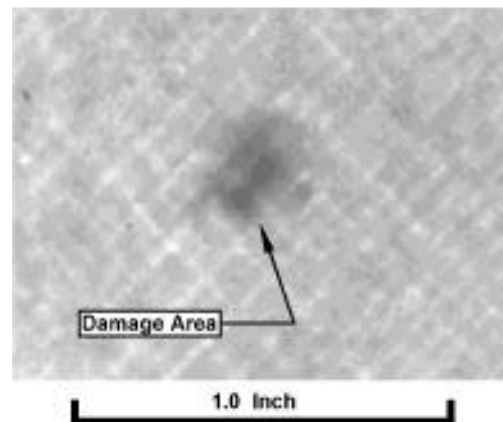
Figure 23. - Damaged sandwich panel impacted at 150 ft/sec.

Selected sandwich panels were subjected to low-velocity impact damage and photographs of the damaged sandwich panels are shown in figures 23 and 24 for impact velocities of 150 ft/sec and 220 ft/sec, respectively. The damaged areas for the 150 ft/sec impact are less than 0.25 square inches. The damage areas for the panels that were perforated with a 0.50-inch-diameter sphere are less than 0.6 square inches.

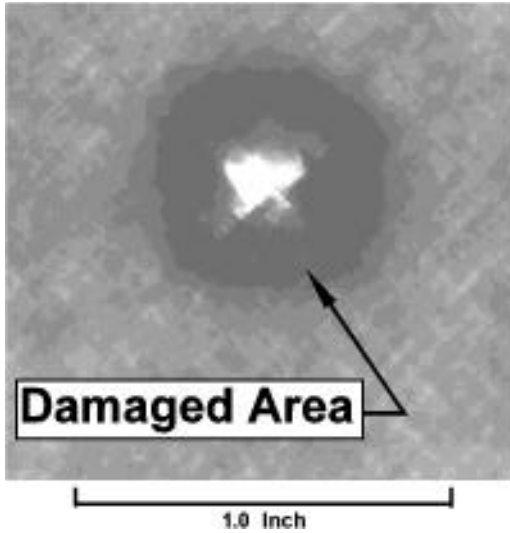
Figure 24. - Damaged sandwich panel impacted at 220 ft/sec.

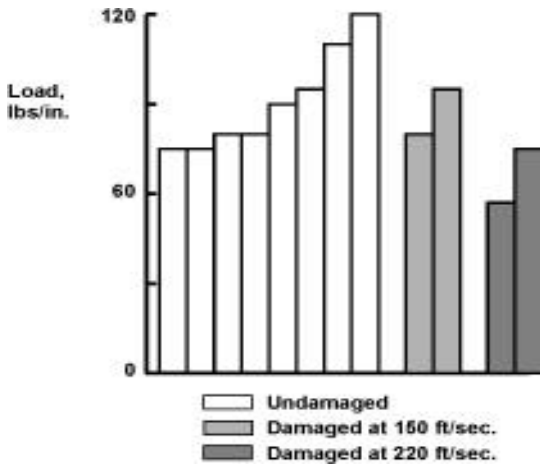
Figure 25. - Summary of initial buckling loads for sandwich panels.

The initial buckling loads are better defined for the sandwich panels than for the solid panels. A summary of the sandwich panel buckling loads is shown in figure 25. The average buckling load for the undamaged panels is 91 lbs/in and the average buckling load for the panels damaged at 150 ft/sec is 88 lbs/in. Panels damaged at 220 ft/sec buckled at 66 lbs/in or a 27 percent lower load than the undamaged panels. The 91 lbs/in buckling load for the undamaged panels is 58 percent of the buckling load predicted by the STAGS linear buckling analysis. The strain gage results for panel SW1 are shown in figures 26 and 27. Gages 1 and 4 (figure 26) are parallel to the buckle pattern and indicate a tensile strain until failure. The results of the STAGS nonlinear analysis are shown by the dashed lines in figure 26 and 27. Strains shown in figure 27 are for gages 3 and 6 which are normal to the buckle pattern. The strains start diverging at approximately 80 lbs/in which is considered to be the buckling load. At 225 to 240 lbs/in and 550 lbs/in this panel appears to change buckling modes. The STAGS analysis predicted a mode change at 270 lbs/in as shown in figure 27. The predicted strain normal to the buckle pattern has the same trends as the experimental strain. These strain results are typical of all of the static tests of the sandwich panels. The experimental and predicted out-of-plane deflections for the center (LVDT 2) and the quarter points (LVDT 1 and 3) of sandwich panel number SW8 are shown in figure 28. The experimental results are from the first static load prior to the start of cyclic loading. A mode change appears to occur at approximately 300 lbs/in for panel SW8. The analysis predicts a mode change at 270 lbs/in as indicated by the dashed curves in figure 28. Good correlation with the analysis is observed up to 60 lbs/in. Plots of the test-machine head displacement are shown in figure 29 as a function of load. Panels SW1 and SW2 are undamaged and have nearly the same response, while the damaged panel SW6 has larger displacements but its stiffness appears to match the undamaged panels. A load decrease is present in all of the curves and corresponds to the mode change observed in the strain gage data. A summary of the

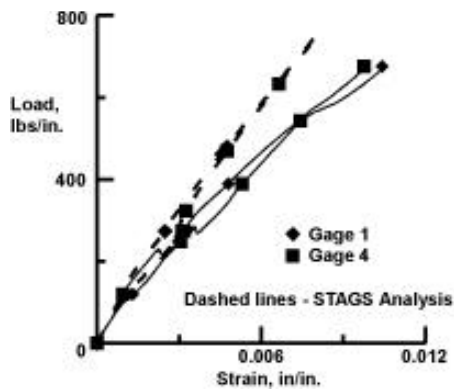
Figure 26. - Comparison of strain parallel to the buckle pattern for Panel SW1.

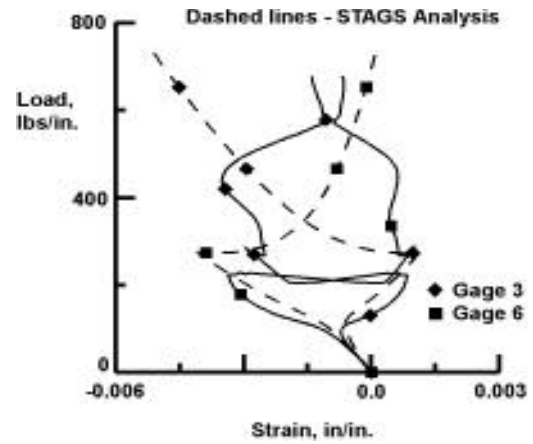
Figure 27. - Comparison of strain normal to the buckle pattern for Panel SW1.

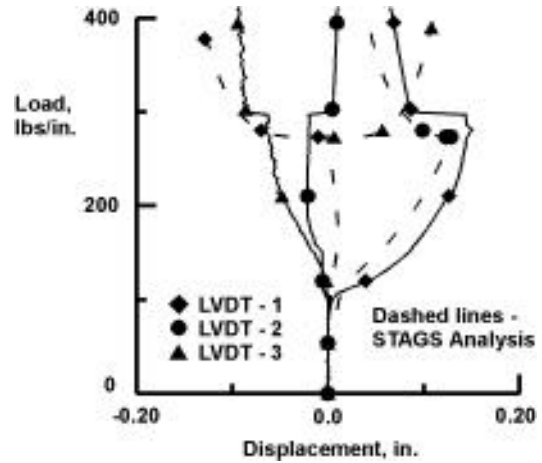
Figure 28. - Comparison of out-of-plane displacements for Panel SW8.

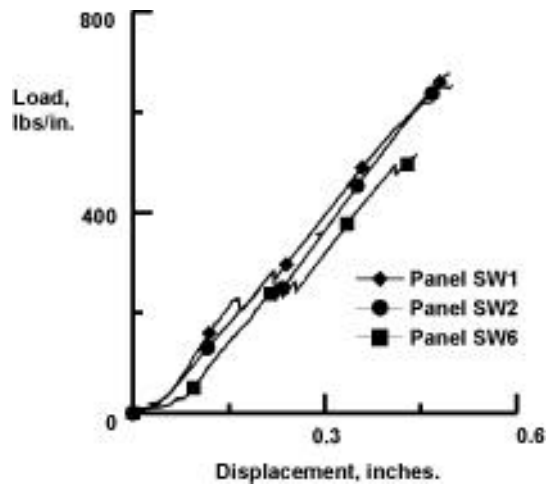
Figure 29. - Comparison of head displacements for sandwich panels.

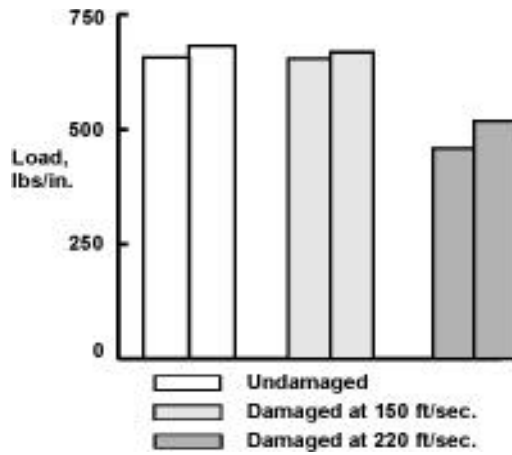
Figure 30. - Summary of ultimate strength for sandwich panels.

static strengths of the panels are shown in figure 30. The average strength of the panels impacted at 150 ft/sec is 661 lbs/in while the average strength of the undamaged panels is 670 lbs/in. The average strength of the panels impacted at 200 ft/sec is 489 lbs/in or 73 percent of the undamaged panel strength. The strength of the undamaged sandwich panels is 95 percent of the strength of the undamaged solid panels while the sandwich panels impacted at 150 ft/sec are 93 percent as strong as the solid panels. The sandwich panels impacted at 220 ft/sec are 16 percent stronger than the solid panels.

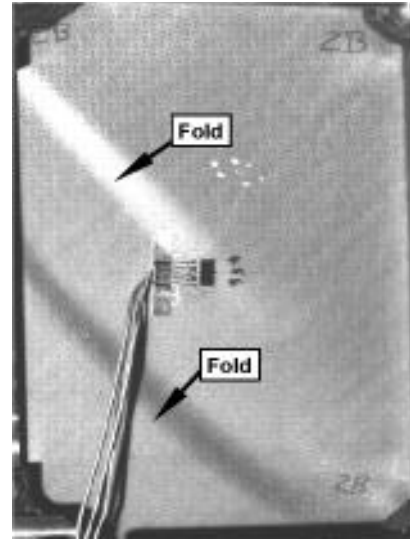
Figure 33. - Photographs of folds in sandwich panel.

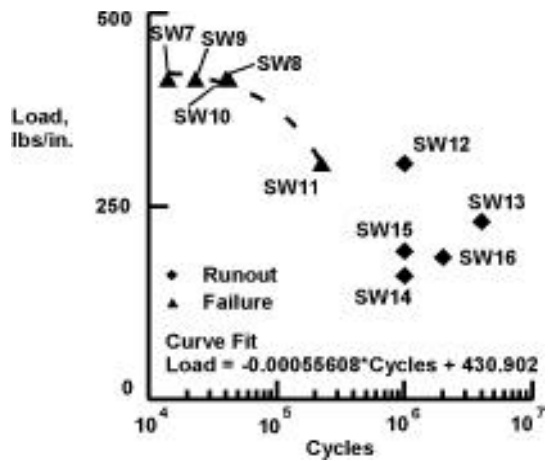
Figure 31. - Load as a function of load cycles for sandwich laminates.

A summary of the sandwich panels that were cyclically loaded is shown in Table 3 and the maximum loads at failure are shown in figure 31 as a function of number of load cycles to failure. A linear curve fit to the data from the five failed panels (triangle symbols) is shown as a dashed line in figure 31. The coefficients for the curve fit equation are also shown in figure 31. The diamond symbols represent runout values and these panels were tested for residual strength. The residual strength results are also shown in Table 3. More test results are needed in the low-load high-cycle range of the plot to produce a full fatigue life curve for the sandwich panels. The average residual strength of the four undamaged sandwich panels with one to four million load cycles is 749 lbs/in. This residual strength is 112 percent of the baseline strength of the undamaged sandwich panels. A comparison of the sandwich panel results in figure 31 with the solid panel results in figure 17 indicates the sandwich panels have a shorter fatigue life than the solid panels. The out-of-plane deflections for the sandwich panels also change as the number of cycles increases as they did for the solid panels (see figure 32). All sandwich panels cracked and failed in a manner similar to the solid panels and most of the sandwich panels exhibited a fold as shown in figure 33 which was set permanently in the panel. A summary of all the failure modes is given in Table 3 using the notation of figure 8. A photograph of a failed sandwich panel is shown in figure 34 where a crack extends along the panel edge and another crack extends from the corner parallel to the fiber direction.

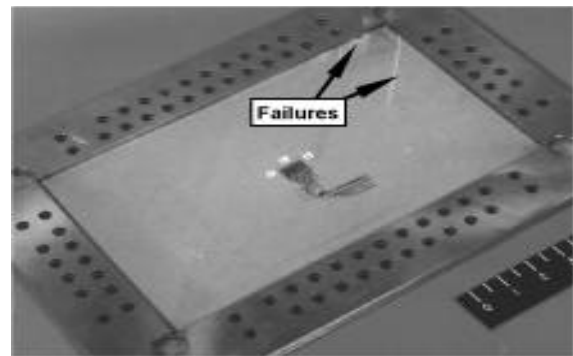
Figure 34. - Failures in sandwich panel.

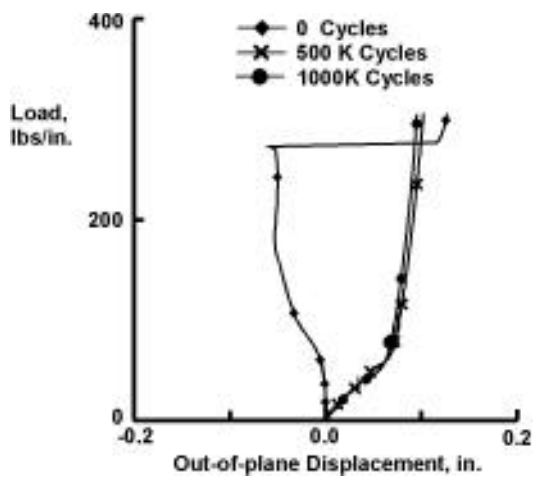
Figure 32. - Comparison of out-of-plane deflections for sandwich Panel SW11.

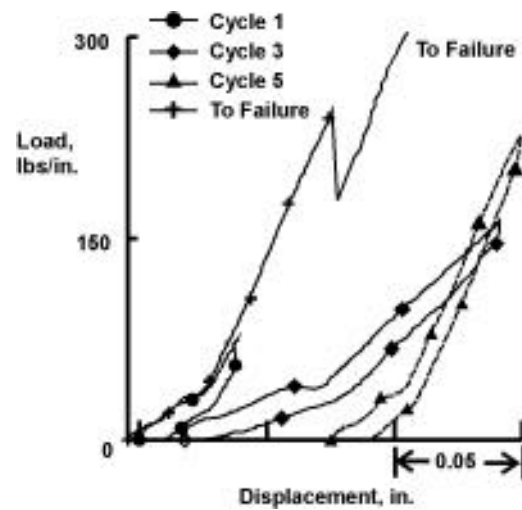
Figure 35. - Comparisons of head displacements for Panel LCF1 with no damage.

is given in Table 4. The strain gage and LVDT data for these panels were recorded for both the load and unload cycles. All strain gage and LVDT response curves returned to their starting point for each load cycle. The load as a function of stroke for three cycles, and load to failure for the undamaged panel and the panel damaged at 220 ft/sec are shown in figures 35 and 36. The hysteresis in the data shown in figures 35 and 36 is considered insignificant since all of the strain gage response curves returned to their starting points. Some of the variation in the data shown in the figures could be the result of tolerances in the in-plane test fixture and load frame. There is no obvious reason for the slopes of the curves to be different in figures 35 and 36.

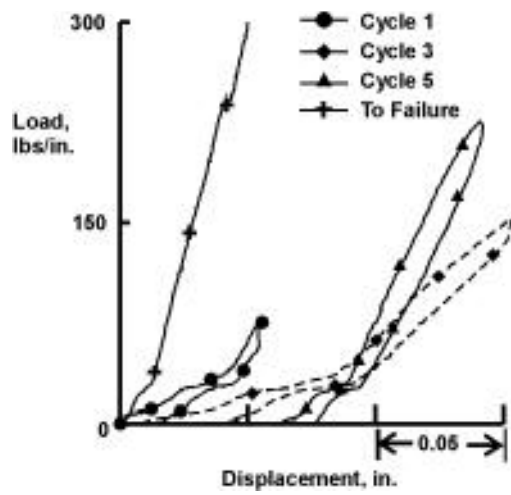
**Figure 36. - Comparison of head displacements for Panel LCF3 that was damaged at 220 ft/sec.**
